FINE-TUNING YOUR RAIL & STILE BITS AND TECHNIQUES FOR PERFECT JOINTS

CMT's matched Rail & Stile Sets are designed to deliver perfect joints, right out of the box. However there are many factors that affect the fit of these joints. These include the condition of your router, the species of wood you choose, your routing technique, and more.

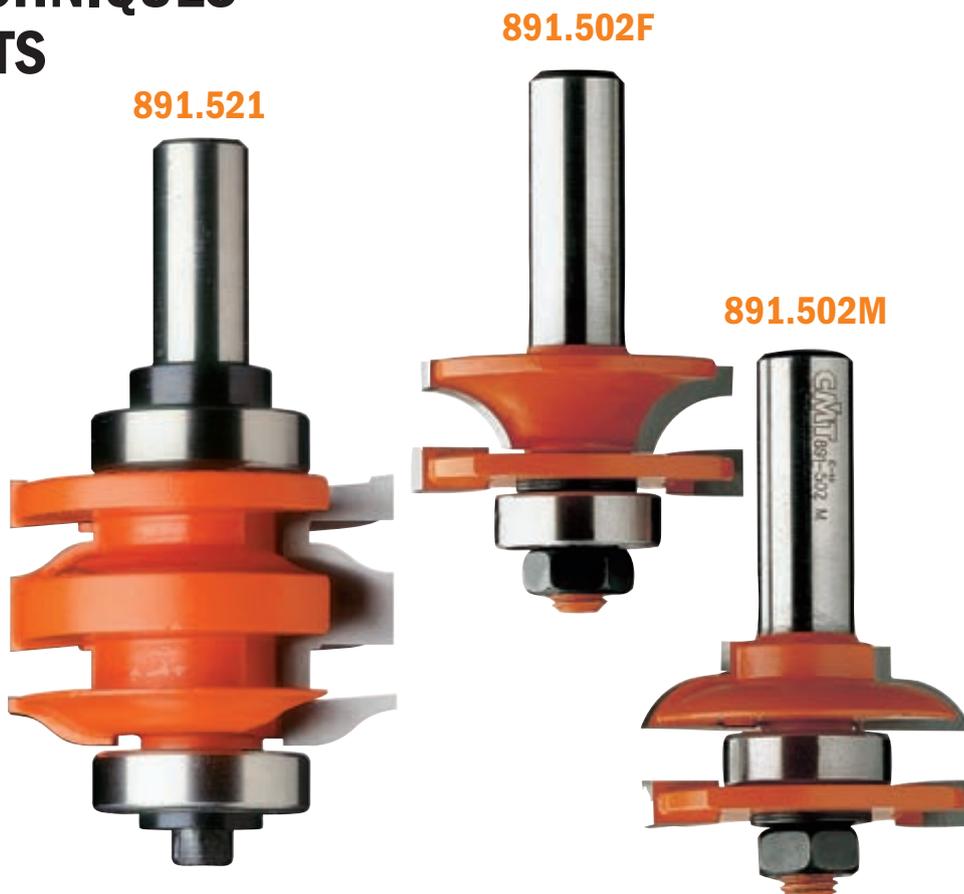
Of course resharpening the bit can also affect the final fit. In order to allow you to compensate for these variables, CMT makes both bits out of two separate sections, which can be shimmed to adjust the fit.

Please notice that only shimmed cutters can be corrected in this fashion.
